Recurrent Outage Baffles Crew

DFA Technology Puts End to Three-Month Problem

Richard M. Forfar, Con Edison
Carl L. Benner and Dr. B. Don Russell, Texas A&M University
Ashok Sundaram, Electric Power Research Institute

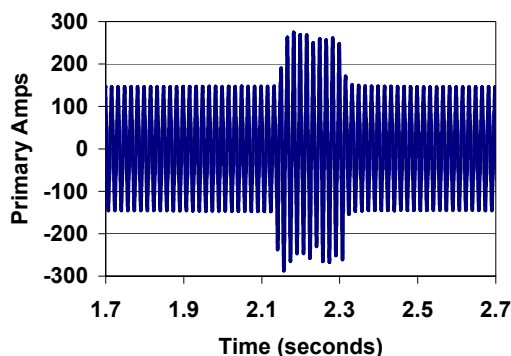
September 11, 2004 03:20:48

Con Ed participates in the DFA project that EPRI sponsors at Texas A&M University. The DFA Prototype at the source substation recorded multiple episodes of low-level arcing leading up to and coinciding with the outages at this location. Figure 1 illustrates the primary feeder currents that the DFA Prototype recorded at the substation during one early episode. Over the next three months, some of the arcing episodes caused outages. Others, such as the one shown in Figure 2, arced briefly and then self-extinguished without causing outages.

Figure 1. Arcing was too small and short-lived to be noticed by conventional means.

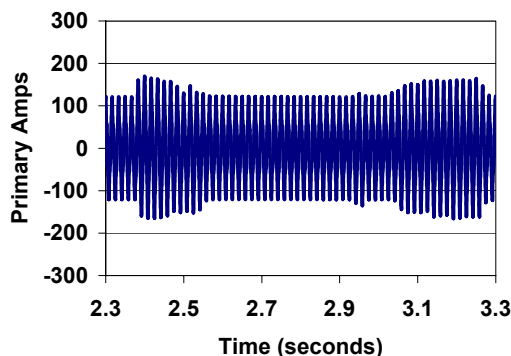
November 15, 2004 01:17:57

Figure 2. More than two months later, the DFA continued to report intermittent arcing.

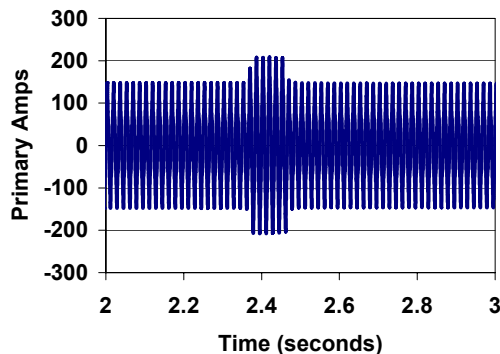
December 07, 2004 00:40:19

Just after midnight on December 7, 2004, the customers with the troublesome service reported what turned out to be the final outage. Having recently become aware that the DFA was reporting a problem, field personnel gave notification of the outage to the engineer with access to DFA reports. He checked DFA records and found that the arcing episode of Figure 3 corresponded to the reported outage time.

Figure 3. DFA's report of arcing coincided with lights-out call.

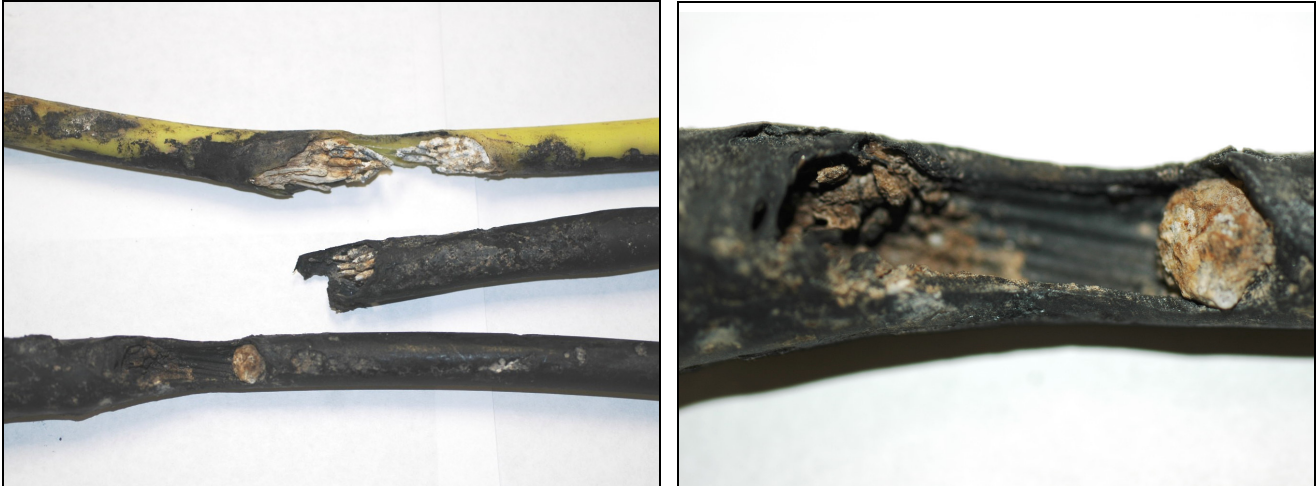
Figure 4. Excavated cables don't appear capable of serving load – but they were!

When personnel later excavated the underground cables, the extent of their damage surprised everyone. Figure 4 shows the physical condition of one section of cable. In the figure, the two black cables are the live legs and the yellow cable is the neutral conductor.

The photographs show very significant damage. A single, brittle strand of the neutral conductor that is shown remained intact while the cable was in service, but broke after excavation. The photograph on the right side of the figure is a close-up of one of the live legs, and shows that the aluminum conductor was entirely missing for a span of almost an inch.

Field personnel excavated all of the affected cables. They found the supply cables up to and inside the crab to be in good shape, but each of the three underground cables between the crab and the customer meters had numerous places with damage similar to that shown in the photographs. What is truly amazing is that these cables actually continued to carry electricity and serve load!

Field personnel deenergized the buried box and the underground service cables, and installed temporary overhead services to affected customers.
