# Mechanisms of Vegetation-Caused Faults on Electric Power Lines

A White Paper – April 2017

Carl L. Benner and Dr. B. Don Russell

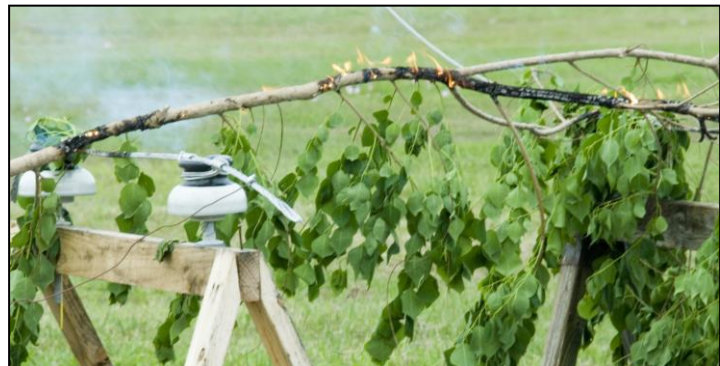
Texas A&M Engineering has conducted experimental investigations into electrical mechanisms associated with vegetation contacting conductors of a 12.5/7.2 kV, multi-grounded-wye primary distribution circuit. Each experiment involved a branch in continuous, simultaneous contact with a phase conductor and a neutral conductor, with three to four feet of separation. These experiments led to the conclusion that such contact typically does not immediately produce high-amplitude fault current. Rather the contact initially produces minimal current (less than one ampere). During that early period, arcing, flame, steam, and smoke appear along the portion of the branch that lies between the conductors, progressively charring the surface of the branch. Hissing and squealing sounds may occur as moisture in the branch flashes to steam and vents through branch bark. The visible and audible activity during this period give an impression of substantial current flow, but electrical measurements indicate that current generally remains in the one-ampere range. If the branch maintains good contact with both conductors for several minutes, without the branch burning in two and falling clear or otherwise losing contact with one or both conductors, the current may increase to an ampere or so, over a period of perhaps minutes, and

then transition suddenly to a high-current flashover. The prolonged, low-amplitude flow of current can damage the conductor, at the points of contact, as can any high-amplitude flashover events that may occur. The aforementioned process occurs when the branch contains moisture. Almost no measurable current flows when the branch is dead and well dried [1,2].
